**A-C ELECTRIC**

**Thermography Inspection around**

**Salt lake City, Utah**

**2/4/2009**

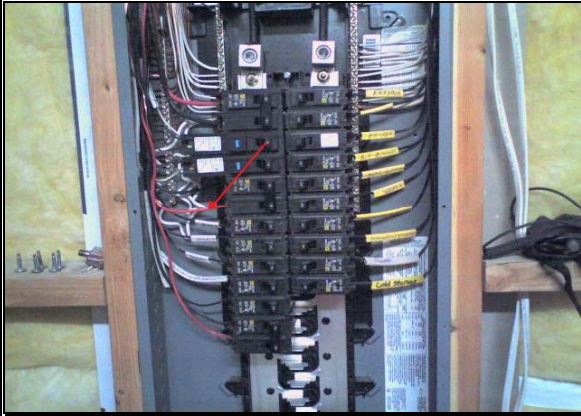
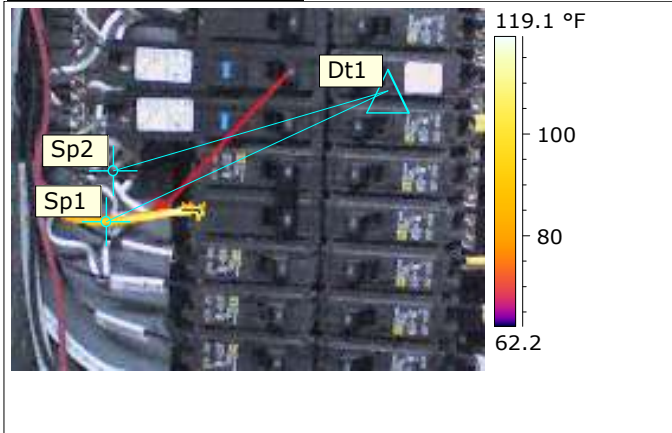
Location	House Panel
Equipment	Sq. D
Type	Home Line
Nom load	100
Actual load	85
Fault	Loose Wire
Recommendation	Repair & Rescan

Sp1 Temperature	98.7 °F
Sp2 Temperature	66.0 °F
Dt1 Value	32.6

Here is a great example of a loose connection in a breaker panel. A loose connection is one of the most common causes of a electrical fire. It is a very simple fix but very difficult to diagnose without the proper tools and equipment.

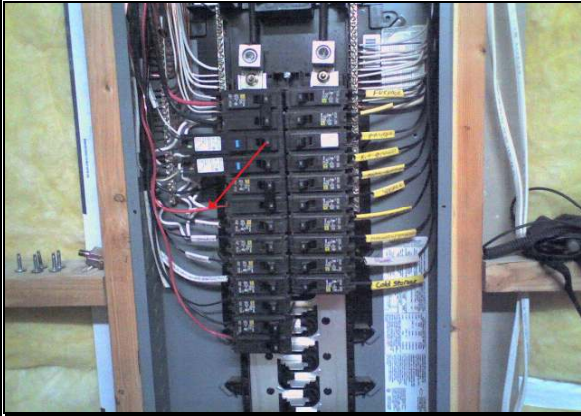
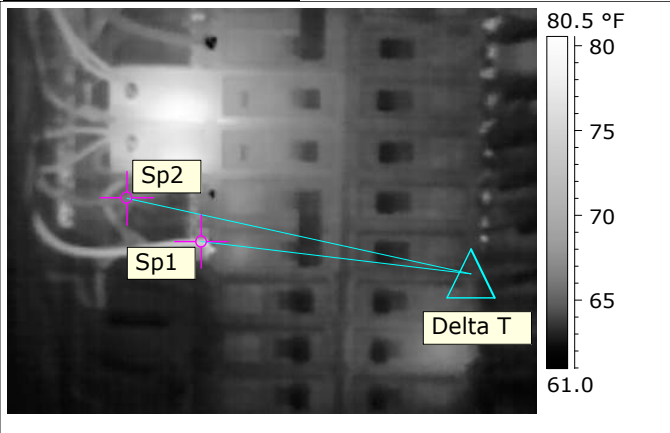
Location	House Panel
Equipment	Sq. D
Type	Home Line
Nom load	100
Actual load	85
Fault	Lose Wire
Recommendation	Repair & Rescan

Sp1 Temperature	75.1 °F
Sp2 Temperature	66.2 °F
Delta T Value	8.9

With the different combinations of color pallets it is easy to find what will work for your facility. In this picture it is easy to see exactly where the problem is. This again is a loose connection on a breaker, this is a very big fire hazard and could cause some very inconvenient down time. This can be easily fixed by a skilled licensed electrician.

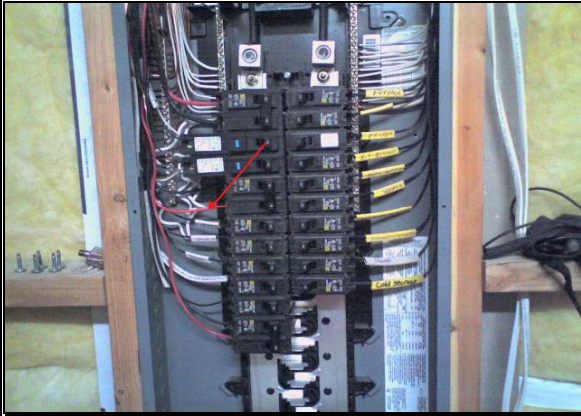
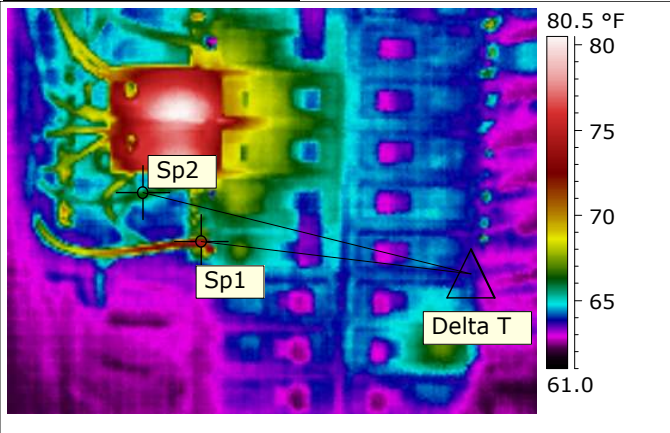
Location	House Panel
Equipment	Sq. D
Type	Home Line
Nom load	100
Actual load	85
Fault	Lose Wire
Recommendation	Repair & Rescan

Sp1 Temperature	75.1 °F
Sp2 Temperature	66.5 °F
Delta T Value	8.6

With the different combinations of color pallets it is easy to find what will work for your facility. In this picture it is easy to see exactly where the problem is. This again is a loose connection on a breaker, this is a very big fire hazard and could cause some very inconvenient down time. This can be easily fixed by a skilled licensed electrician.

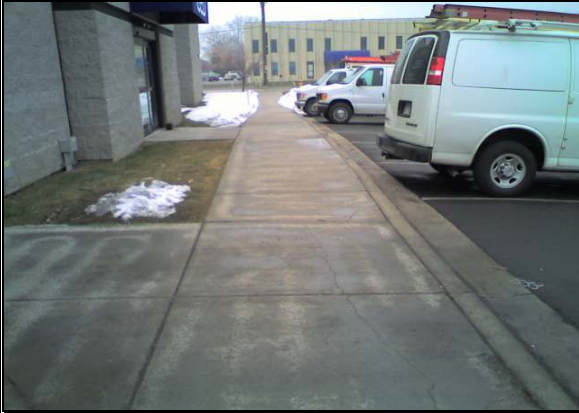
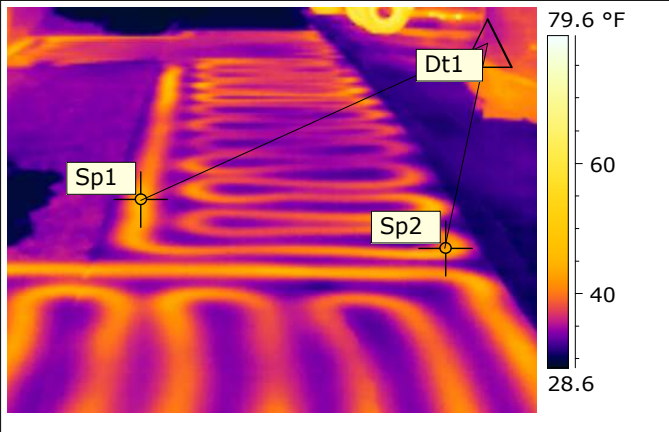
Location	SLC
Equipment	Heat Trace
Type	?
Nom load	30
Actual load	23
Fault	None
Recommendation	N/A

<b>Sp1.Temperature 45.4 °F</b>
Sp2.Temperature 44.4 °F
Dt1 1.0

In this picture, it is very clear and easy to see the underground heat trace, that is used to keep the snow and ice off the sidewalks for the convenience of the customers entering the building. With the use of thermal imaging it is fast and easy to spot problems that could occur with the system. And if there was a problem, it would be easy to pinpoint his location to make the repair quick, easy and cheaper than ripping out the entire sidewalk.

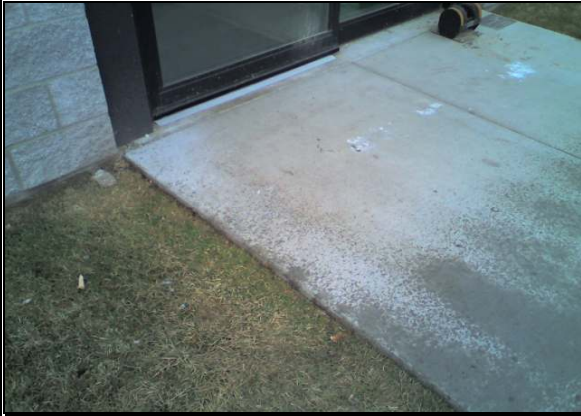
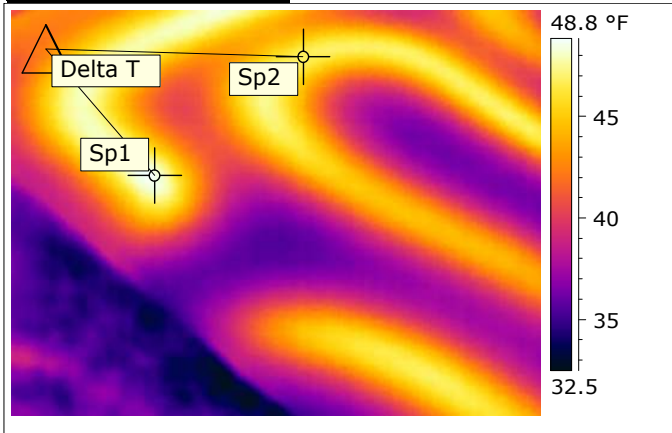
Location	SLC
Equipment	Heat Trace
Type	?
Nom load	30
Actual load	23
Fault	None
Recommendation	N/A

Sp1 Temperature	48.5 °F
Sp2 Temperature	46.9 °F
Delta T Value	1.7

Here you can see where the heat trace enters the sidewalk from the control cabinet mounted on the wall.

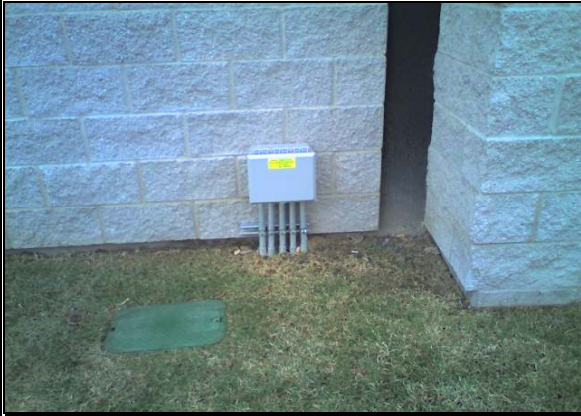
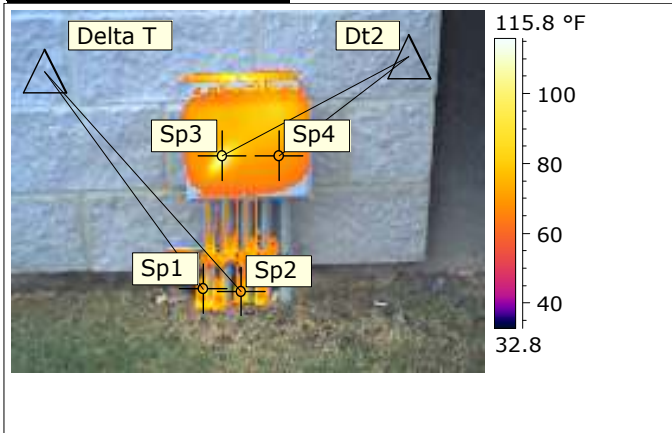
Location	SLC
Equipment	Heat Trace
Type	?
Nom load	30
Actual load	23
Fault	None
Recommendation	N/A

Sp1 Temperature	75.3 °F
Sp2 Temperature	73.1 °F
Sp3 Temperature	112.7 °F
Sp4 Temperature	70.6 °F
Delta T Value	2.2
Dt2 Value	42.0

Here is the heat trace cabinet mounted on the exterior wall of the building. You can see on the cover the box that there is a hotspot inside. By further examination, we found that this is where one connection was little closer to the exterior of the box than the others.

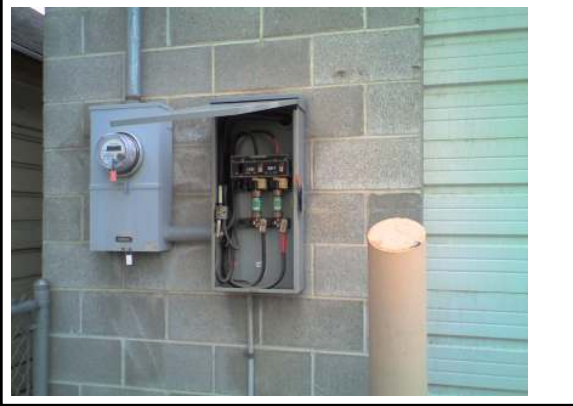
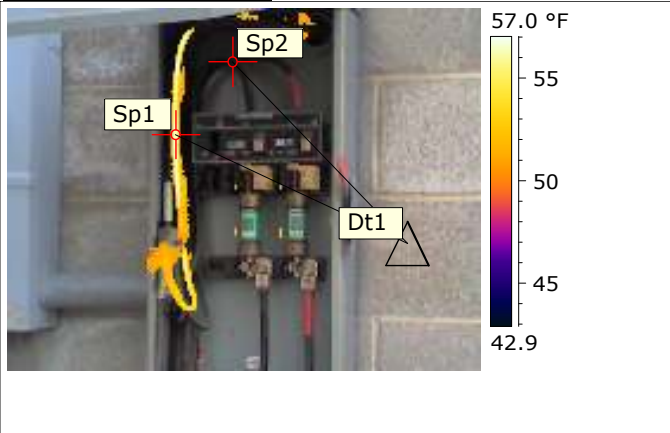
Location	SLC
Equipment	GE Disconnect
Type	200 A 240 V
Nom load	200
Actual load	145
Fault	Loose Connection
Recommendation	Repair & Rescan

Sp1 Temperature	56.8 °F
Sp2 Temperature	49.6 °F
Dt1 Value	7.1

This picture clearly shows that there is a hot wire inside this disconnect. With the use of our FLIR T250 infrared camera this problem was quickly detected and fixed. Without this technology this problem could have existed for years and could have ended in a catastrophic failure.

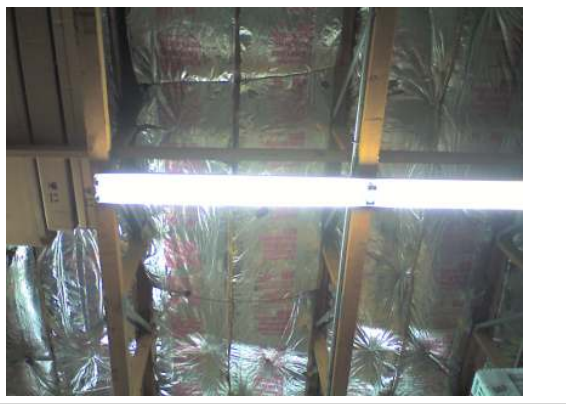
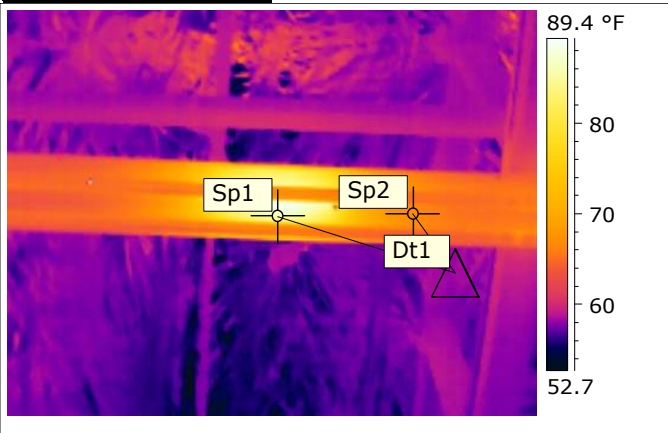
Location	SLC
Equipment	8' Strip Light
Type	?
Nom load	?
Actual load	?
Fault	Hot Ballast
Recommendation	Check, and replace if necessary.

Sp1 Temperature	85.1 °F
Sp2 Temperature	66.4 °F
Dt1 Value	18.7

In this picture, you can see the heat of the ballast is putting off. Ballasts do put off a lot of heat, but this is a little excessive and should be checked to make sure that everything is okay.

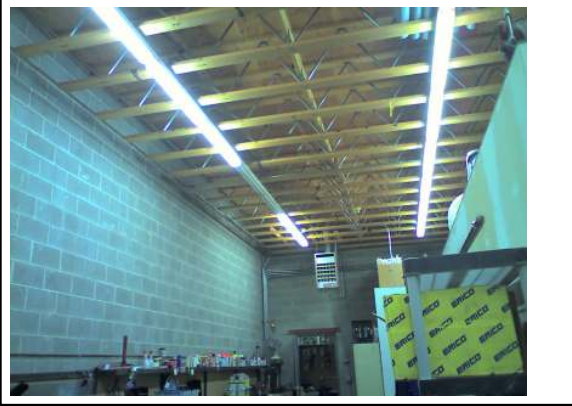
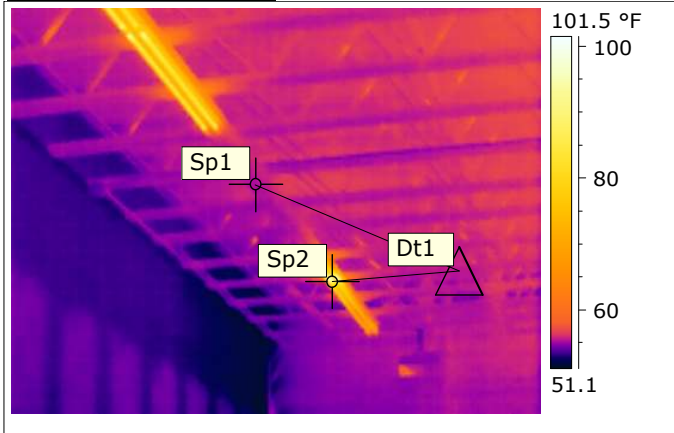
Location	SLC
Equipment	8' Strip Fixture
Type	?
Nom load	?
Actual load	?
Fault	Bad Ballast
Recommendation	Repair

Sp1 Temperature	55.3 °F
Sp2 Temperature	83.8 °F
Dt1 Value	-28.5

In this picture is easy to tell what the ballast is no longer working. If the ballast was working there would be a heat signature from it. So in this case, the lamps are most likely burnt out. This can be a very useful tool in areas that are hard to access.

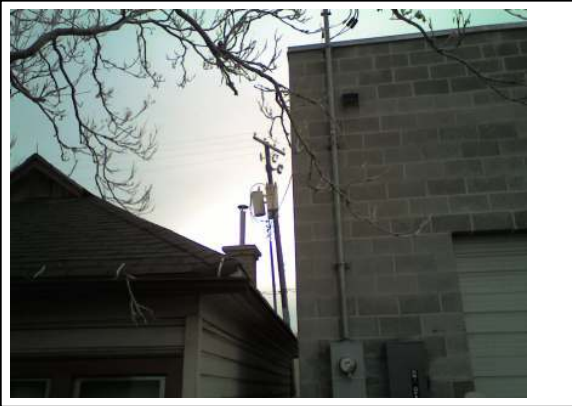
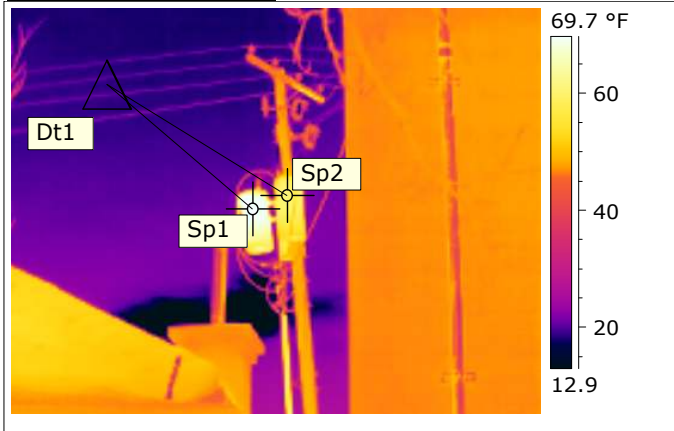
Location	SLC
Equipment	Transformer
Type	?
Nom load	?
Actual load	?
Fault	None
Recommendation	N/A

Sp1 Temperature	69.5 °F
Sp2 Temperature	60.0 °F
Dt1 Value	9.5

In this pitcher, you can tell the transformer on the left is working a little harder or maybe a little low on oil.

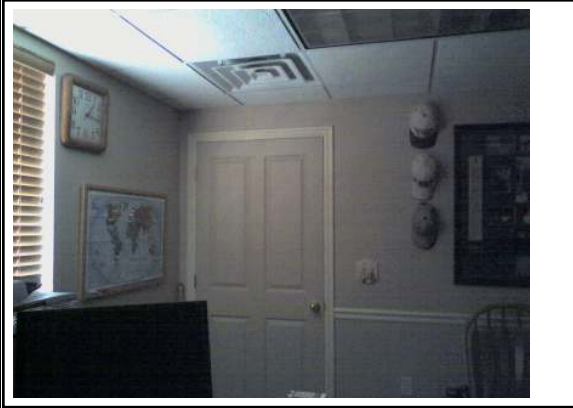
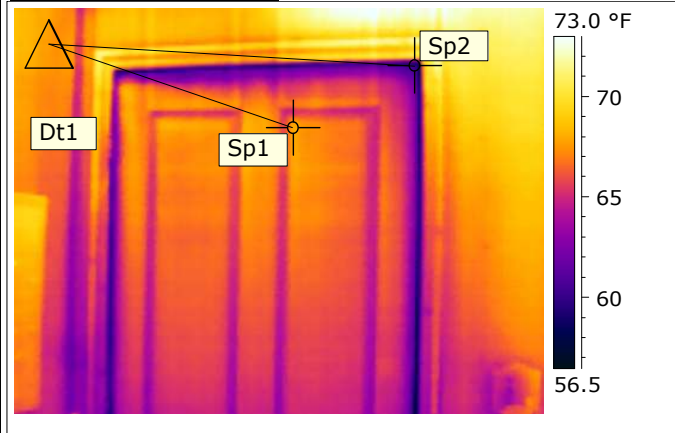
Location	SLC
Equipment	None
Type	
Nom load	
Actual load	
Fault	None
Recommendation	N/A

Sp1 Temperature	68.0 °F
Sp2 Temperature	59.1 °F
Dt1 Value	8.9

In this picture, you can see this door is improperly sealed. You can see the cool air from the outside to leaking into the warm room. This is a very easy fix with a little bit of sealing tape.

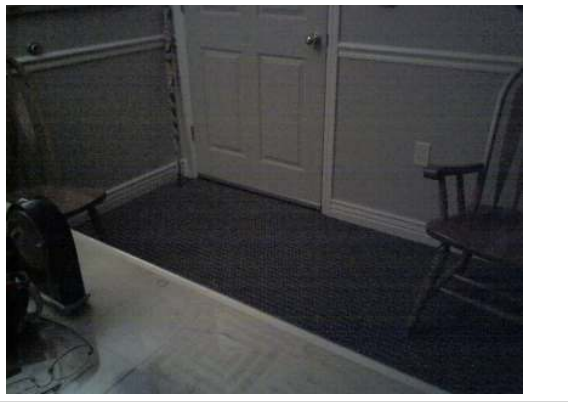
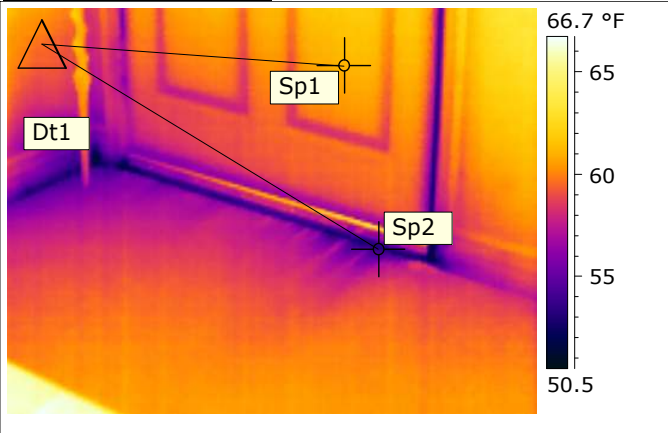
Location	SLC
Equipment	
Type	
Nom load	
Actual load	
Fault	None
Recommendation	N/A

Sp1 Temperature	61.0 °F
Sp2 Temperature	54.3 °F
Dt1 Value	6.8

This is another picture of the cool air from the outside entering the warm room. You can see the cool streaks that are formed on the floor from the cool air.

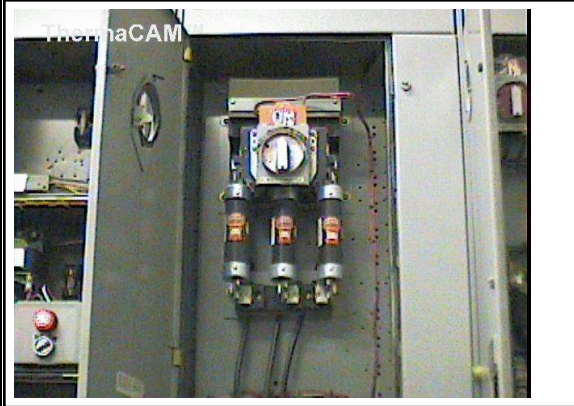
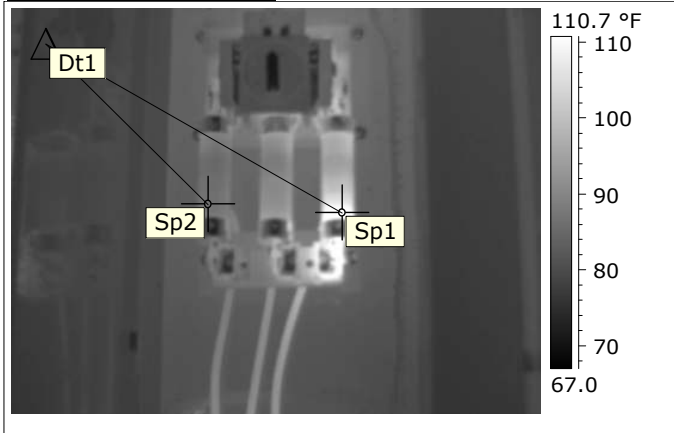
Location	SLC
Equipment	Fused Disconnect
Type	3ph, 600 V
Nom load	
Actual load	
Fault	Loose Fuse Clip
Recommendation	Repair & Rescan

Sp1 Temperature	117.4 °F
Sp2 Temperature	87.0 °F
Dt1 Value	30.3

Here is a great example of fused disconnect that is experiencing a loose connection on one of the fuse clips. This can cause premature fuse failure or even a fire. Through the use of thermal technology. We are able to quickly diagnose a problem and figure out the best solution to fix the problem. This problem is easily fixed by a qualified electrician.

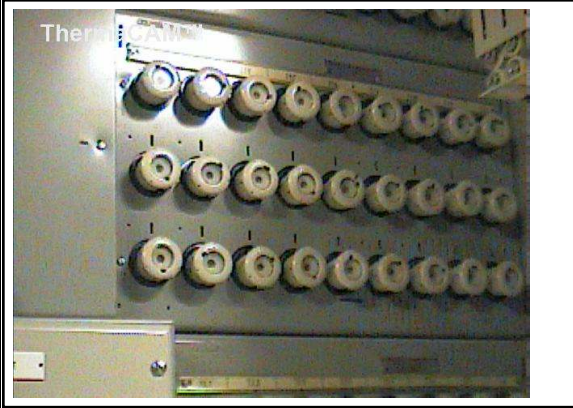
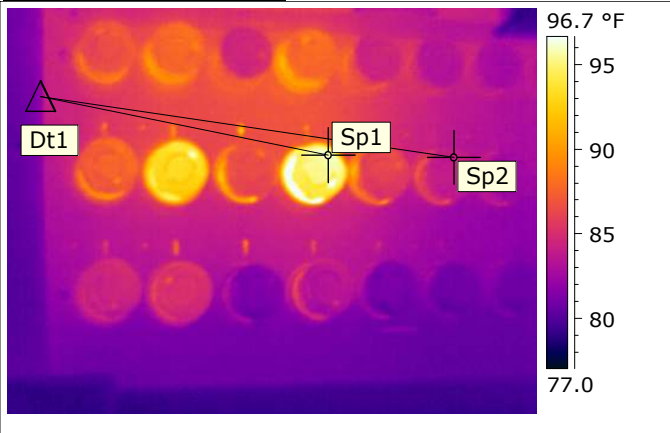
Location	SLC
Equipment	Capacitor Bank
Type	
Nom load	
Actual load	
Fault	Over Heating Capacitor
Recommendation	Repair & Rescan

Sp1 Temperature	96.2 °F
Sp2 Temperature	84.2 °F
Dt1 Value	12.0

In this picture we are looking at a capacitor bank. It is easy to tell that a couple of these capacitors are running way too hot and could be close to failure. Through the use of predictive maintenance, we are able to catch these problems and fix them before they become a catastrophic event.
